Report on the investigation of
injury to a passenger on board a

Delta 8.5m RIB

River Thames, London

Report No 1/2011
January 2011

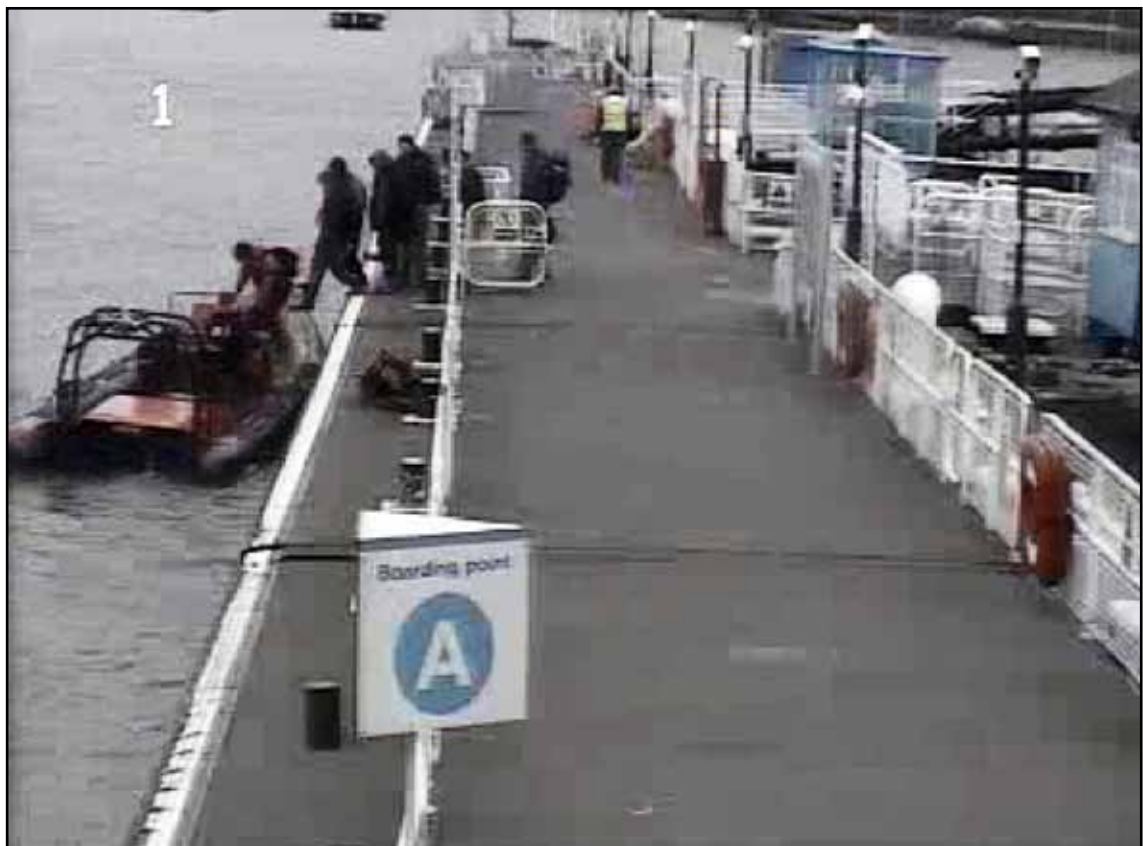
Figure 3

At 0700 on 6 May 2010, the 8.5m Delta RIB arrived at Greenwich pier to embark eight workers for transfer to the rigs. At 0701 the last of the men arrived and boarded the boat (**Figure 3**). He donned a lifejacket and sat on the locker forward of the helmsman's console, as there was no other area of the boat available to him (**Figure 4**).

Personnel embarking at Greenwich Pier - Image from CCTV

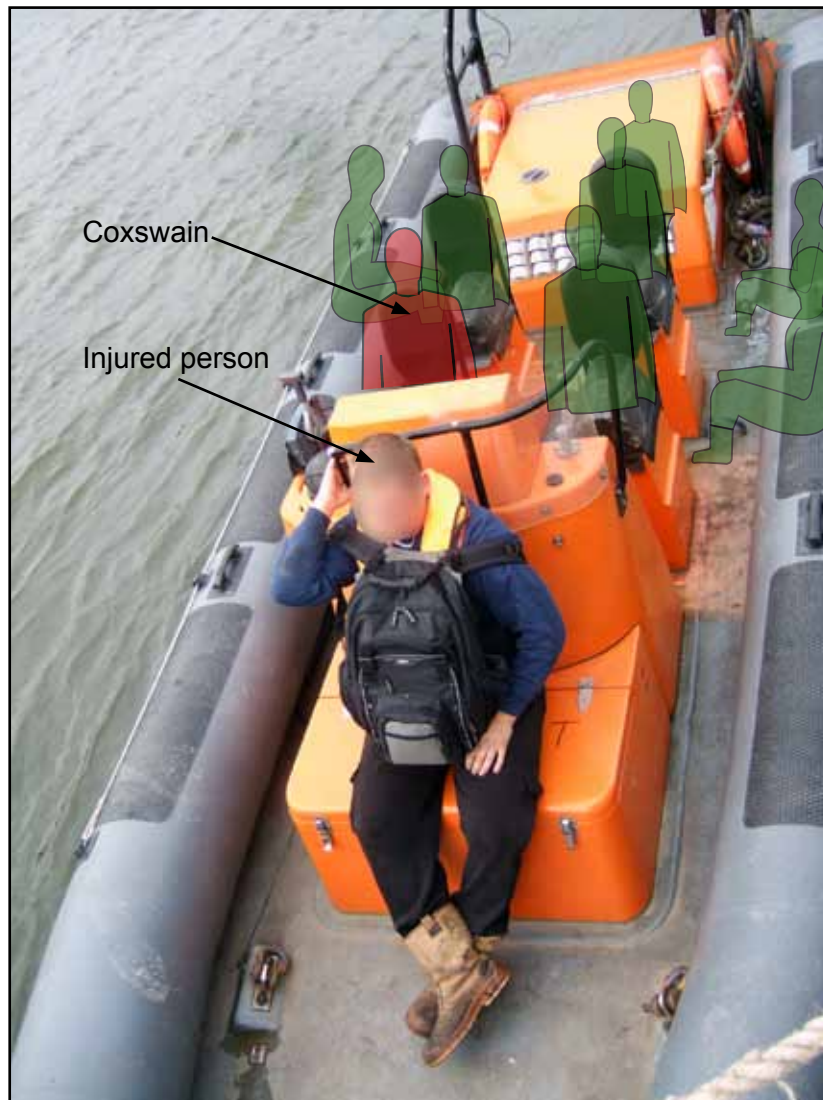
Figure 4

Reconstruction showing location of injured person and other passengers at the time of accident

There were no hand-holds or foot straps in this location so he alternated his grip between a vertical stanchion on the helmsman's console and the lip of the locker on which he was seated. During the passage, the man was frequently lifted bodily from the locker and, due to the motion of the boat was unable to alert the helmsman to his discomfort.

In this accident the injured person was seated on a forward locker. This was not intended for use as a seat, it had no padding and no available hand-holds or foot straps (**Figure 4**). His situation was exacerbated by the location of the locker in the forward part of the RIB, where the motion is most violent (**Annex B**).

The lack of restraints forced him to hold on to the stanchion located behind his shoulder. His posture was further worsened by the need to wear his rucksack on his chest due to the lack of available safe stowage (**Figure 10**). It is notable that the casualty in the *Celtic Pioneer* investigation (Report No 11/2009)² was also seated in the forward part of the RIB and the report cites this and the casualty's posture as contributory factors to the injury.

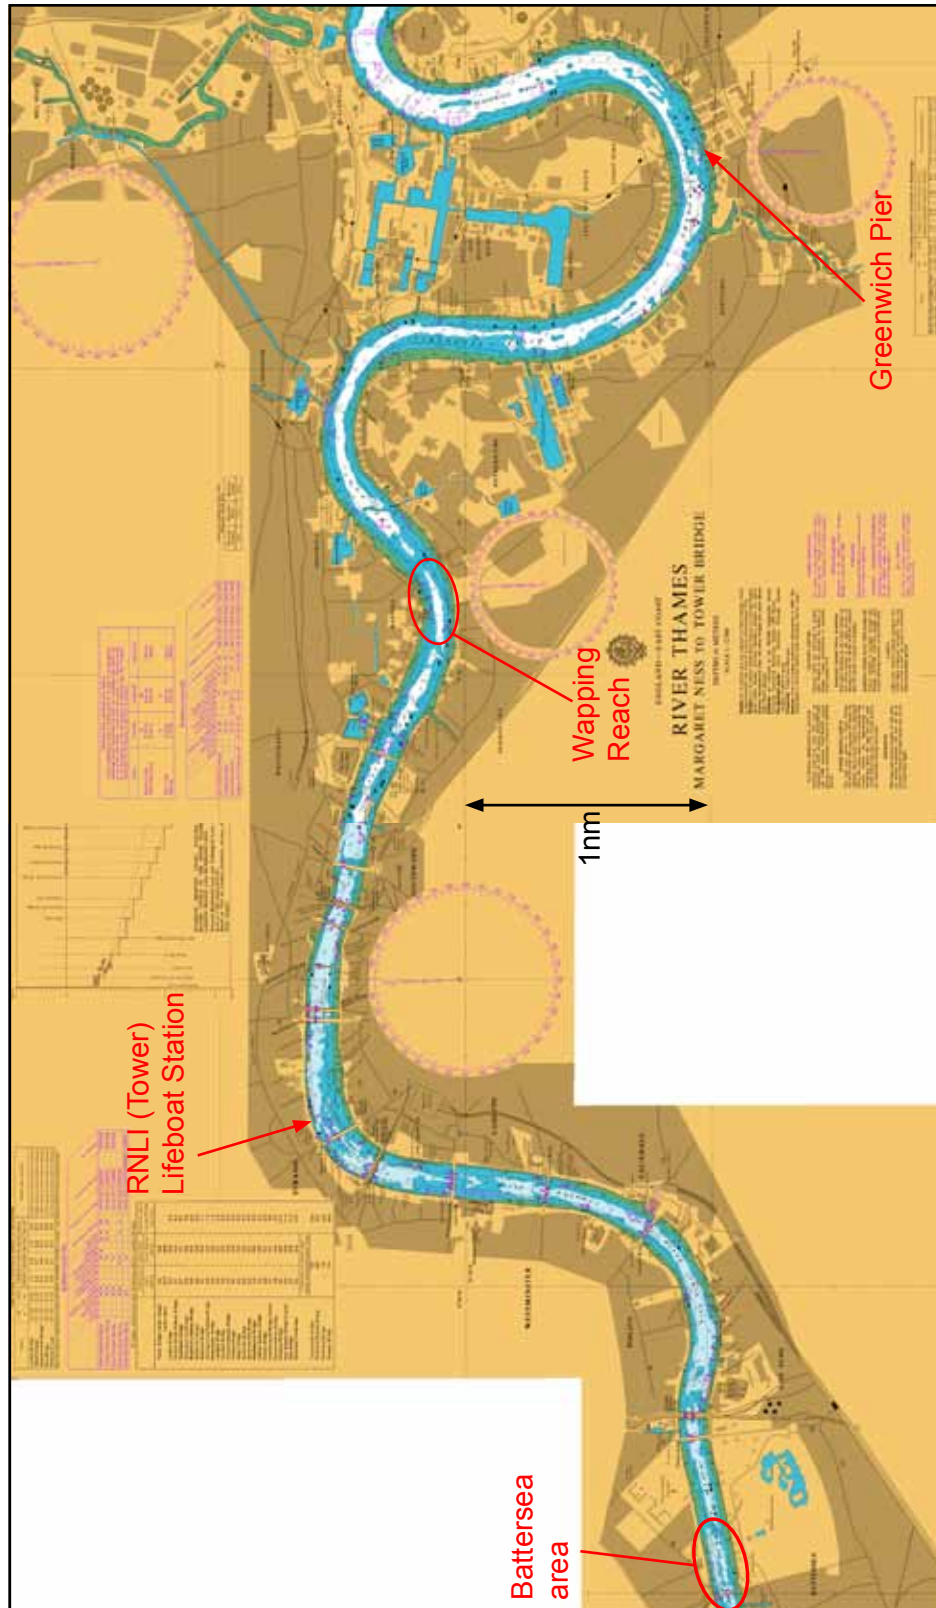
Figure 5

At 0708 the boat was in Wapping Reach (**Figure 5**) when the man felt an intense pain in his lower back. He cried out and immediately placed himself in a prone position on the forward deck of the boat. The helmsman stopped the boat and a co-worker assisted the injured man, who was in considerable distress and unable to move without intense pain in his back.

Chartlet of River Thames from Waterloo Bridge to Greenwich showing location of accident - Wapping Reach

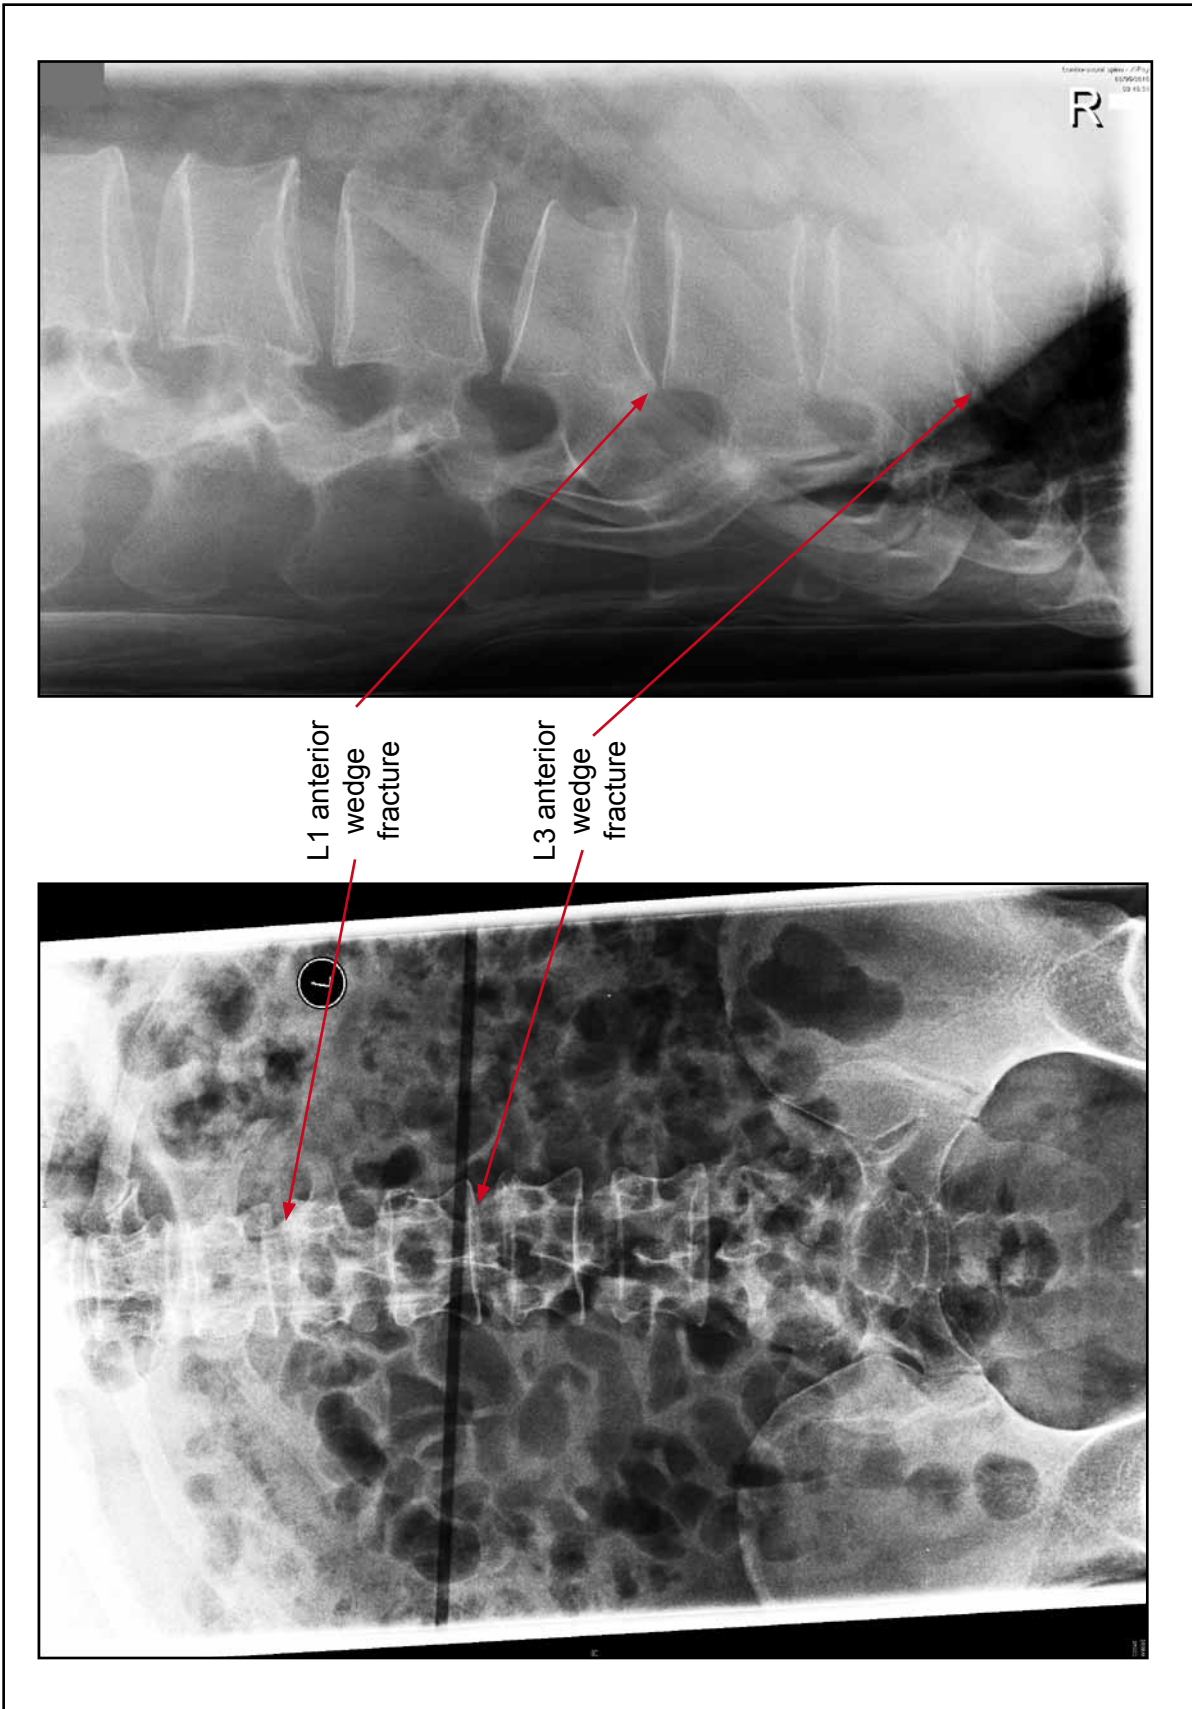
Figure 6

As a result of the accident the injured person suffered anterior wedge fractures of the first and third lumbar vertebrae (L1 and L3) (**Figure 6**). While in hospital he was also given a neurological assessment, which proved to be normal. He was mobilised and discharged the day after the accident, and a few days later was fitted with an external body brace. He remained off work for more than 4 months while he recovered from the injury. He commenced a graduated return to work a few months later and resumed full-time employment 6 months after the accident, although he was still receiving physiotherapy treatment at the time this report was published, some 8 months after the accident.

X-ray images of injury

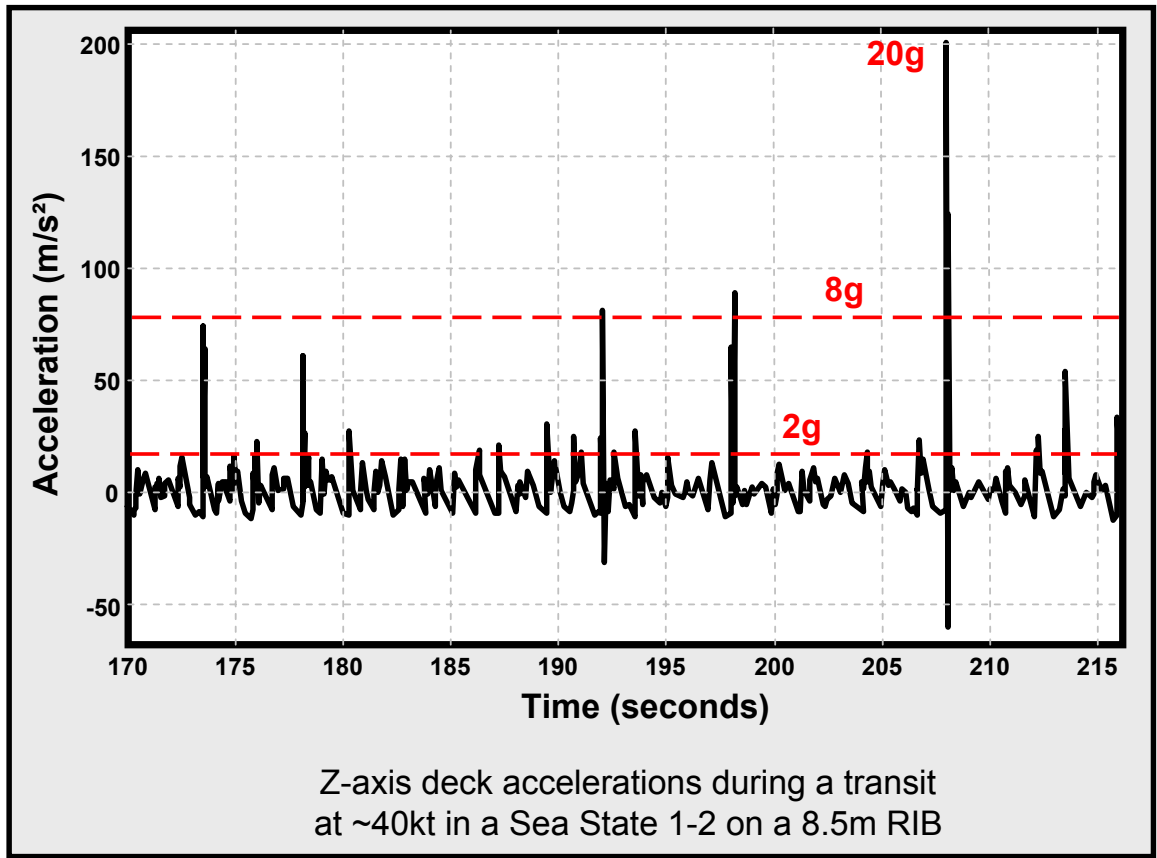
Figure 8

Research, referenced in the guide, provides a graphical example of the magnitude and frequency of repeated shocks measured during trials on the deck of an 8.5m RIB travelling at 40 knots between a sea state 1 and sea state 2 (**Figure 8**). The trials found that the occupants were exposed to constant shocks in the region of 2g, regular shocks in the region of 6g and occasional shocks of up to 20g. These figures equate to the WBV EAV being exceeded within 15 minutes and the ELV within approximately 30 minutes (**Figure 9**). The guide also states that *“the risks of acute and chronic injury are manifested in an increase in spinal, knee, arm, or neck injury. This can be from a single high energy event (e.g. a single 20g impact) or as a result of a long term exposure to a large quantity of smaller energy events (e.g. multiple 2g impacts)”*. The research also found that the magnitude of shocks transmitted through the deck of a high-speed craft is greater towards the bow.

Magnitude and frequency measurements for repeated shocks recorded on an 8.5m RIB

The trials demonstrated that the repeated shocks experienced during a high speed passage can be of sufficient magnitude to cause impact injuries. They also concluded that a person exposed to the shock and vibration levels shown in **Figure 8** dramatically exceeds the exposure limits set by the Vibration Regulations.

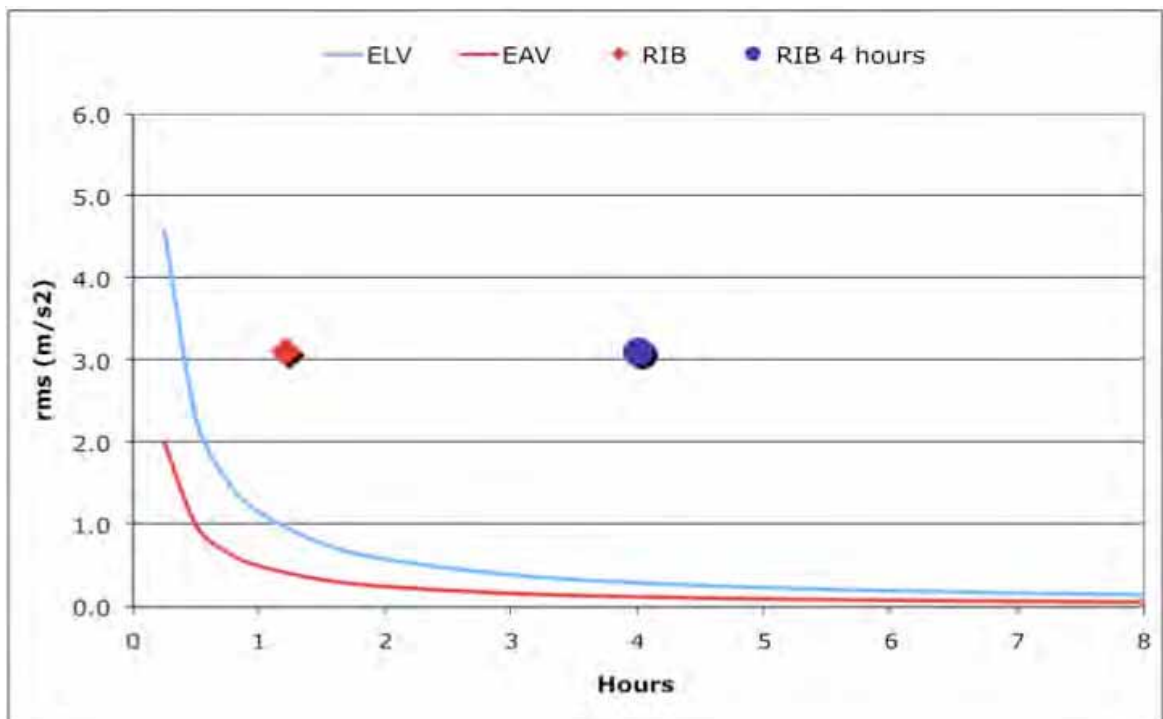
Figure 9

An example of how a 28' RIB travelling at ~40kts in a sea state 2 will exceed the EU WBV Exposure Action and Limit Values.

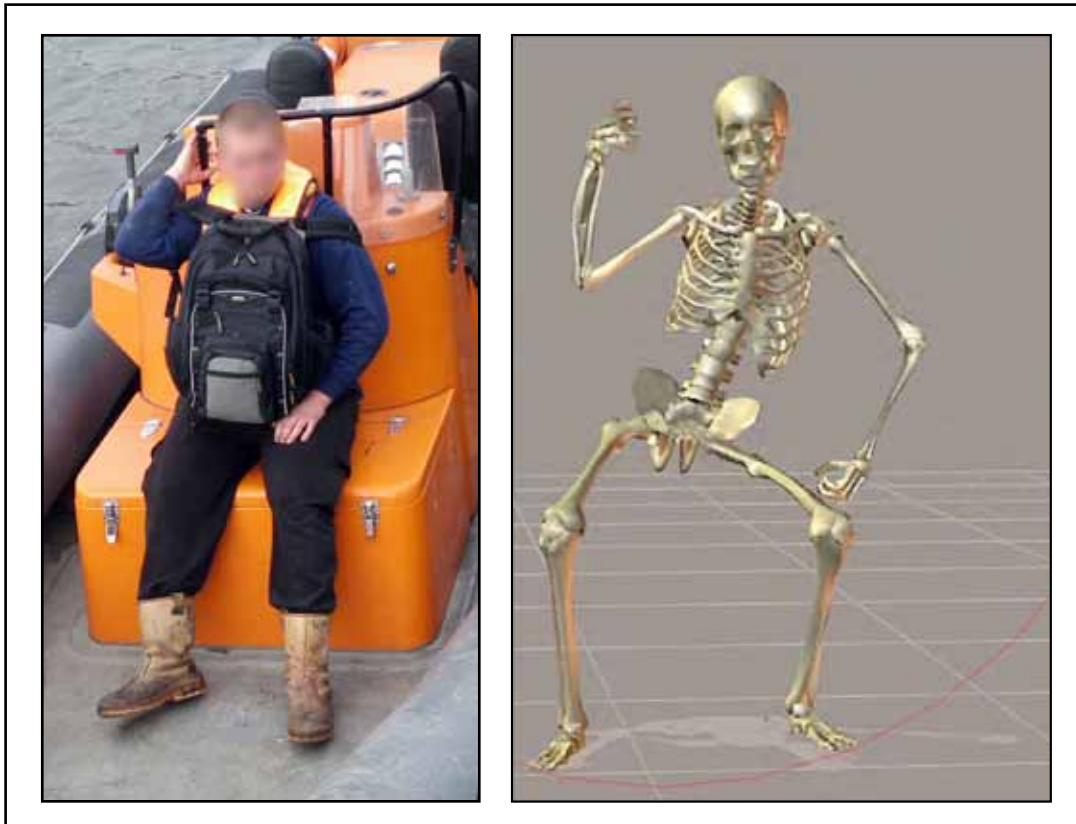
Illustration of the possible spinal alignment of the casualty at the time of the accident

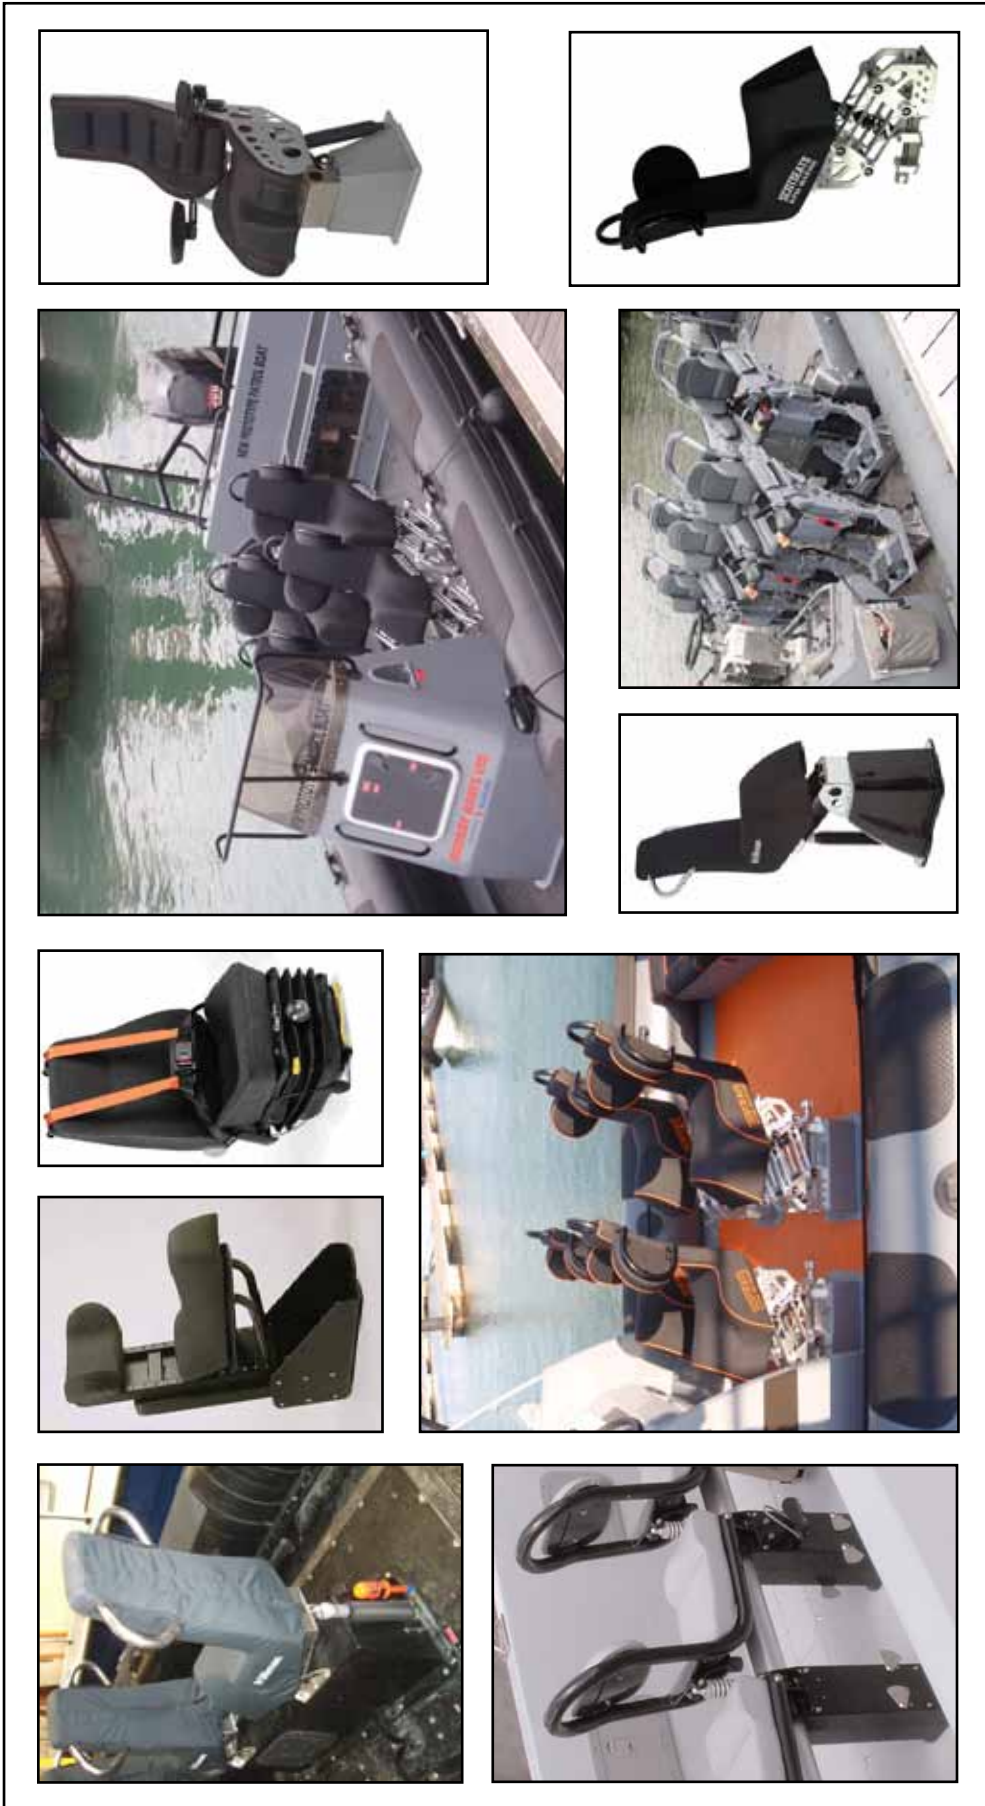
Figure 11

Examples of high-speed craft seats, which are designed to reduce the effects of vibration and shock impacts

“Seating in high speed craft needs to be such that the individual is coupled to the seat as effectively as possible and that any comfort layer helps to attenuate rather than reinforce the impact” (Annex A). Even in benign conditions, at moderate speeds the locker lid would have made a poor seat and, as the accident shows, at high speeds the risk of injury from such ad hoc seating arrangements is significant. There are an increasing number of manufacturers producing dynamic seats designed to mitigate the effects of WBV and shock impacts, thus enabling the requirements of the Vibration Regulations to be met **(Figure 11)**.

Ideally, dynamic seats would be provided for all occupants. However, this is not always appropriate. Manufacturers need to give clear guidance on the level of protection from vibration and shock afforded by the seating provided, taking into account the intended use and the requirements of the Vibration Regulations. They should also ensure that the hull shape is suitable for the craft’s intended use and area of operation and that there is sufficient provision to stow baggage and equipment. Similarly, owners need to take account of the limitations imposed by the seating arrangements, available stowage and hull shape when determining the operating procedures and limitations.
